SLICK

Service Bulletin

SB1-06

SUBJECT: Removal of pin #2 on SS1001 SlickSTART™ ignition boosters.

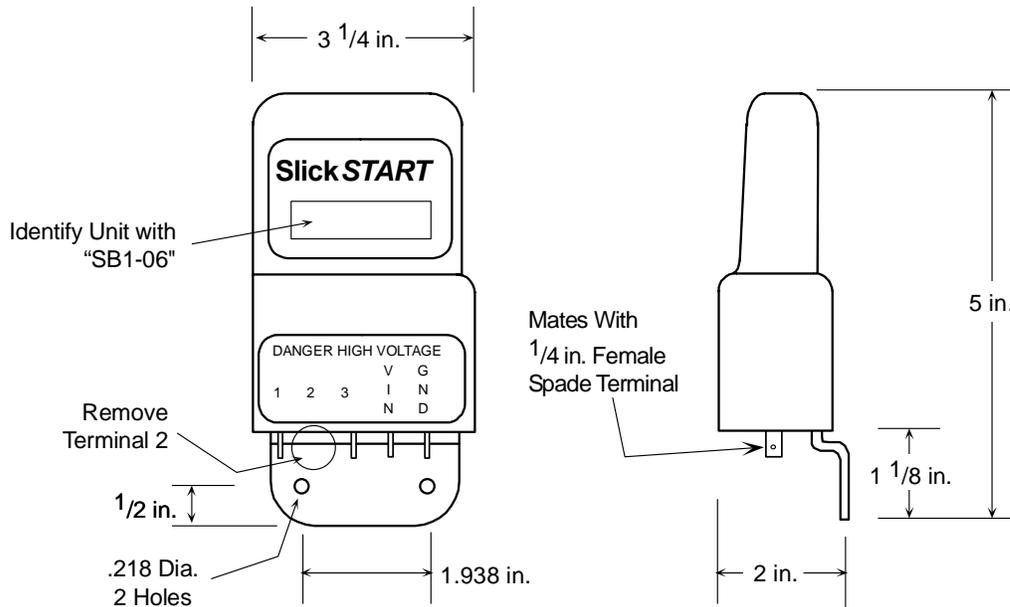
Figure 1

Previous installation instructions for the SS1001 allowed connection of the SlickSTART™ to both left and right magnetos. Unison Industries now recommends the removal of this connection method because it potentially compromises the redundancy of the ignition system. Therefore, this unit must be disconnected from the right hand magneto and pin #2 must be removed from the SlickSTART™ unit, thus allowing the right magneto to operate independently.

In most applications, this pin will not be connected, but the pin should still be physically removed to prevent any connection in the future.

2. If the SlickSTART™ unit is accessible, cut of the #2 pin as short as possible to prevent future use of this pin. See Figure 1. If necessary, remove the SS1001 from the firewall to complete this operation then re-install it.

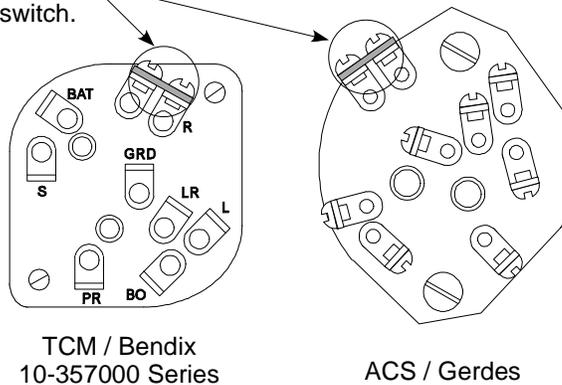
Figure 2

CAUTION: ON ENGINES WITH ONE RETARD BREAKER MAGNETO OR ONE IMPULSE COUPLING MAGNETO INSTALLED, FAILURE TO GROUND THE RIGHT MAGNETO DURING START WILL RESULT IN ENGINE KICKBACK AND POSSIBLE DAMAGE TO THE STARTER AND ASSOCIATED ACCESSORY GEAR TRAIN.

- A. In most applications, the right magneto can be grounded during start by the ignition switch. If the wiring connections on the back of the ignition switch are similar to those shown in Figure 2, a jumper can be added to the two terminals shown to provide a ground path during start.

Verify that this jumper is installed if your aircraft is equipped with this type of switch.
