# LANCAIR COLUMBIA 400 SPIN RECOVERY TESTING

**Sonja Englert**

Lancair Certified Aircraft

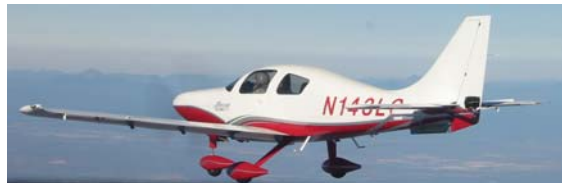
Figure 1 Columbia 400

The Columbia 400 is a four-seat, composite, turbocharged airplane with a gross weight of 3600 lb and 98 gal usable fuel. This paper continues the story started by Len Fox during the 2004 Symposium. After the loss of the first test airplane, a second Columbia 400 was prepared for spin testing with a redesigned spin recovery system. The goal was to find a configuration in which the Columbia 400 would meet the requirements for 14CFR 23.221 for one turn spin recovery while retaining the 'looks' of the airplane and with the least amount of changes to the airframe / molds. About 50 different configurations were tested during the 1.5 years of the Lancair spin program. These tests were considered high risk, the spin recovery chute was successfully used four more times.

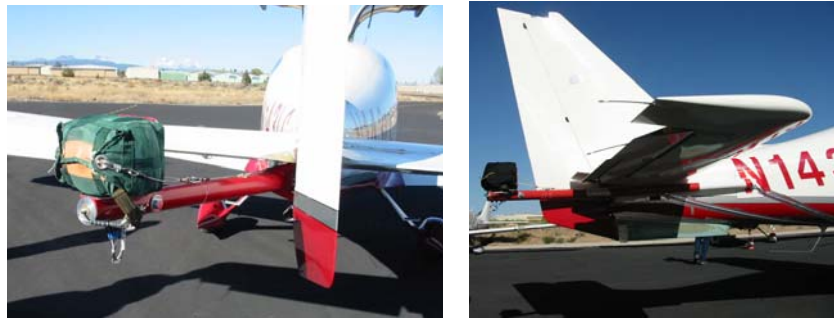
Figure 2 Left Side and Right Side Spin Boom with Chute

The redesigned recovery system was mounted on the left side of the aft fuselage for most of the tests. The spin recovery chute was deployed by a spring loaded pilot chute, which pulled the main chute out of

its bag. The aerodynamic effect of the side mounted spin boom was investigated, it was equivalent to a slight rudder deflection to the side it was mounted on. To fly coordinated with the left side spin boom installed, more right rudder than normal was needed while with the right side spin boom very little right rudder was needed at full power. The spin recovery characteristics were best without a spin boom, slightly degraded with the left side spin boom (slightly longer recovery turns) and worst with the right side spin boom (right hand spins were worst). Tuft tests showed that the spin boom shielded a small area of the vertical tail and rudder, where it was mounted.

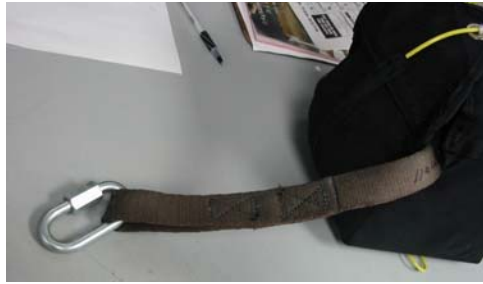
Figure 3 Chute Attachment

After several deployments the line attaching the chute to the airplane showed evidence of chafing at the D-ring. The equipment was sent to a local parachute rigger who had been packing the spin chute for us and had built the chute bags. He cut the chafed end off and stitched a new loop. No one noticed that the thread he used was not the same strength as the original stitching, but weaker.

During the next deployment, this stitching failed, fortunately after the spin rotation was stopped, but just before the pilot could cut the chute away. This confirmed that the loads during chute deployment are lower than with the airplane descending with the chute fully deployed on its tail.

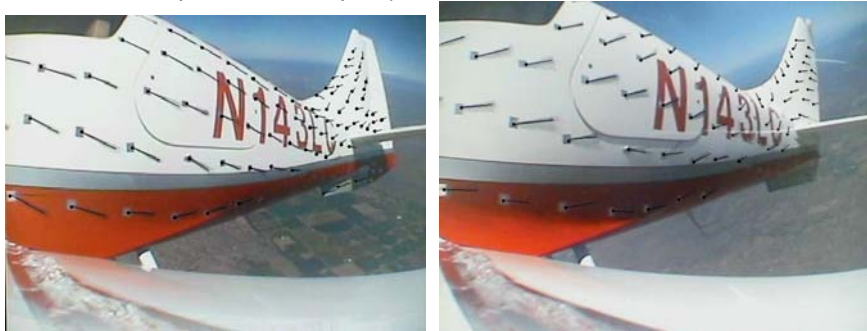
Figure 7 Left Rudder Sideslip and Right Rudder Sideslip

The airflow at the vertical tail was investigated in normal flight and yawed flight, to look for ways to make it more effective and to investigate why the airplane would take longer to recover from right spins ( $1/4$  to  $1/2$  turn more compared to left spins).

In normal flight at all speeds down to stall speed the airflow would be roughly parallel to the fuselage longitudinal axis. In yawed flight with rudder deflections, the airflow changed until it was about parallel to the vertical tail leading edge. This led to another modification we called a vertical tail fence, like a stall fence on a swept wing, which was attached to the leading edge of the vertical tail at about mid span .

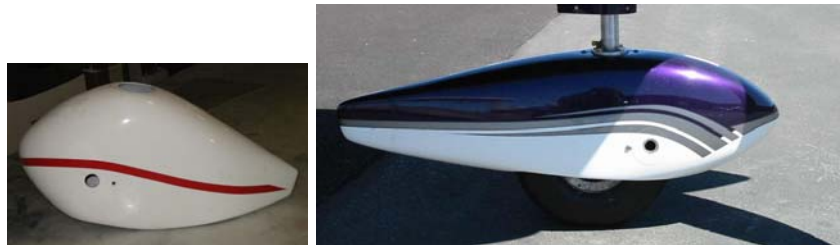
Figure 9 Small and Standard Nose Wheel Pant

Next a smaller nose wheel pant was built and spin-tested in the hope that it would have less effect on recovery. The opposite turned out to be true; with the small nose wheel pant recoveries took longer than with the standard large nose wheel pant.

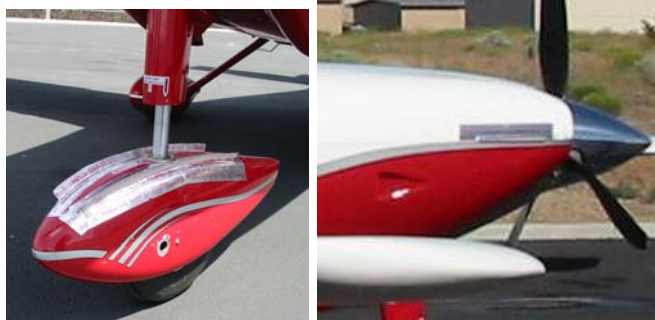
Figure 10 Nose Wheel Pant Strips and Cowling Spin Strips

It was then attempted to reduce the amount of side force in spins caused by the nose wheel pant and cowling by attaching "Spin Strips" onto them in various locations. These were intended to stall the airflow in yawed flight and therefore reduce the side force created by those otherwise rounded parts. The shape of the spin strips was varied from L-profile to triangular, the locations were varied in height and length. The spin strips

were tested separately and together on cowling and nose wheel pant. In general the recovery times were reduced and about the same as without the nose wheel pant. Spin entries seemed slower. Both together were not an improvement over either the cowling strips or nose wheel pant strips by themselves. Longer cowling spin strips did not improve recoveries over the size shown in Figure 10. Delayed rudder was tested eventually, and it failed (recovery after >6 turns without the use of the spin chute).

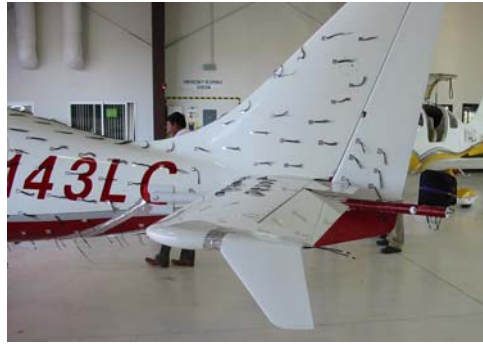
Figure 12 Long Taillets

A different version of taillets was installed on the horizontal tail (Figure 12). The flaps up, power off, normal recoveries were better than before. Tests were continued with power on, flaps up and delayed rudder, which worked to the left but failed with >5 turns to the right. It recovered without the use of the spin chute. The taillets were removed.

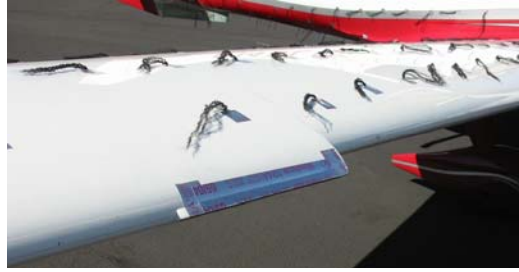
Figure 13 Cuff Stall Strips, taped on

The standard nose wheel pant was reinstalled and all other mods removed. The effect of the wing cuffs was then reduced by adding 12" long stall strips on the cuff leading edges. This improved the consistency of left and right recoveries considerably (left spin recoveries were typically  $\frac{1}{4}$  turn, right spin recoveries were typically  $\frac{3}{4}$  turn, this changed to  $\frac{1}{2}$  turn for both). With the nose wheel pant installed it passed all tests up to an altitude of 18,000 ft including the delayed rudder case. It still failed the delayed rudder case to the right at 25,000 ft, the spin chute had to be used again. At this point the airplane was still covered with tufts and had a small video camera mounted on top of the fuselage. The cuff stall strip length

was increased to 18". It passed all tests including high altitude delayed rudder.

The tufts and camera were removed and the tests repeated. It failed delayed rudder to the right, but recovered after 4 ½ turns. The cuff stall strips were increased to 24" length and this time all spin tests passed at all altitudes. The stall characteristics still met 23.201 and 23.203 requirements. This was the configuration that is now certified to 25,000 ft.
